**Flood Control Project Maintenance
Levee Inspections****LMA District Cover Sheet****Spring 2014 Levee Inspection Results****Reclamation District No. 0544 Upper Roberts Island**

Spring 2014 Levee Inspection Results

Reclamation District No. 0544 Upper Roberts Island

Waterway			Bank	Unit Miles
Unit No. 01 San Joaquin River			Left	6.11
	Spring (March - May)	Summer (June - August)	(September - November) Fall	Winter (December - February)
Unit Maintenance Rating (Fall Only)				
Date of Inspection	04/10/2014 - 04/10/2014			
DWR Inspector	Richard Willoughby			
Accompanied By

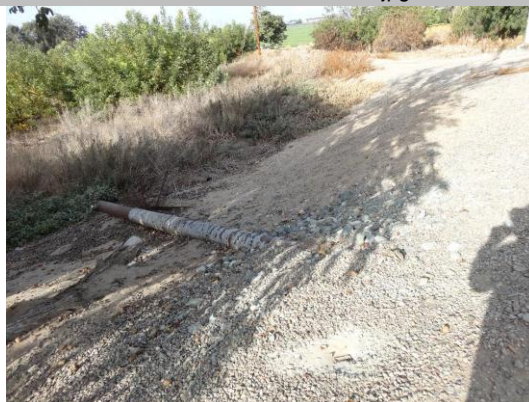
Photo 1 of 1 : UCIP_3807.jpg

LM Start	0.01	Rating **	M	Issue No.	36
LM End	0.01	Issue Type +	En	Location *	CR
Category	Supplemental			GPS Latitude/Longitude	
				Start	End
Item	DWR UCIP Field Study			37.870296 °	37.870296 °
				-121.329826 °	-121.329826 °
DWR ID	DWR_RD0544_01_s_2014_36				
Action/Comments					
Inspector Comments: FS_ID:23851					
EP_NO: N/A					
Repair Type:					
Crossing Status:					
UCIP Comments: Appears abandoned. May need proper abandonment. Pipe exposed on landside slope.					
FIELD_STRUCT_DESC: A 12-inch steel pipe through the levee, 2 feet below levee crown. Appears abandoned. Only visible on landside slope. No pipe and other features visible on waterside.					
FS Date: 10/29/2013

LS view: exposed 12-inch steel pipe on levee slope. Appears abandoned.

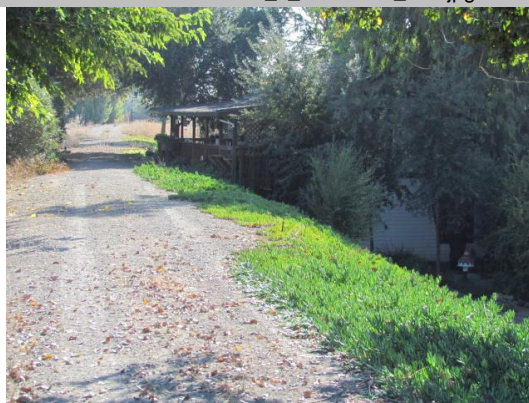
Photo 1 of 1 : richard_s_20140320_289.jpg

Looking south at landscaping on landward slope.

LM Start	0.71	Rating **	M	Issue No.	10
LM End	0.71	Issue Type +	En	Location *	WS
Category	Earthen Levee			GPS Latitude/Longitude	
				Start	End
Item	Vegetation			37.863575 °	37.863575 °
				-121.322367 °	-121.322367 °
DWR ID	DWR_RD0544_01_s _ 2012_10				
Action/Comments					
Landscaping

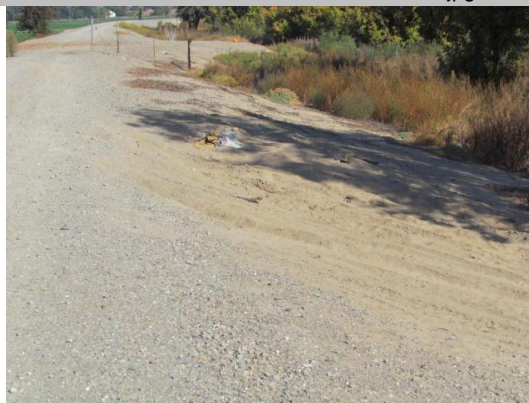
Photo 1 of 2 : richard_s_20140320_313.jpg

LM Start	1.56	Rating **	M	Issue No.	64
LM End	1.56	Issue Type +	Ma	Location *	WS
Category	Earthen Levee			GPS Latitude/Longitude	
				Start	End
Item	Slope Stability			37.854081 °	37.854081 °
				-121.321268 °	-121.321268 °
DWR ID	DWR_RD0544_01_f_2013_64				
Action/Comments					
Repair the levee slope damaged by vehicle traffic and prevent access where possible.					
Inspector Comments: Damaged levee slope due to fishermen using slope as a ramp.

Looking northeast at waterward slope.

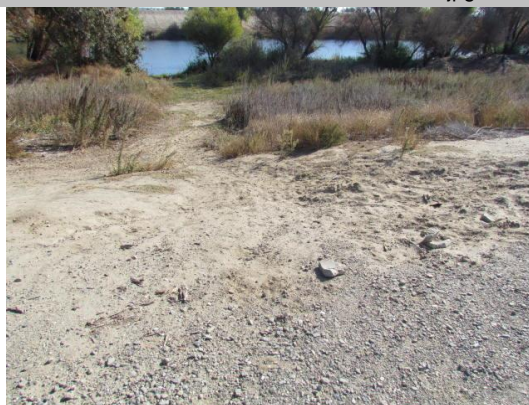
Photo 2 of 2 : richard_s_20140320_314.jpg

LM Start	1.56	Rating **	M	Issue No.	64 (cont)
LM End	1.56	Issue Type +	Ma	Location *	WS

Looking east at damaged waterward slope.

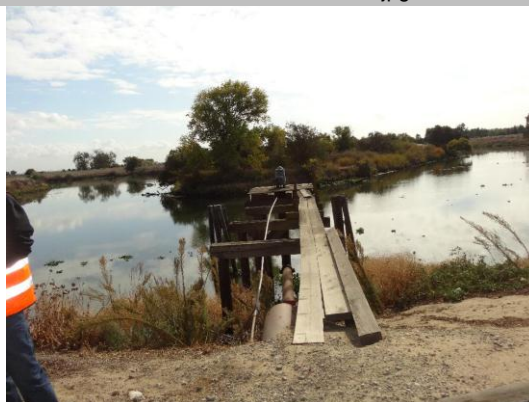
Photo 1 of 1 : UCIP_3808.jpg

LM Start	1.74	Rating **	M	Issue No.	38
LM End	1.74	Issue Type +	En	Location *	LS
Category	Supplemental			GPS Latitude/Longitude	
				Start	End
Item	DWR UCIP Field Study			37.854506 °	37.854506 °
				-121.323886 °	-121.323886 °
DWR ID	DWR_RD0544_01_s _ 2014_38				
Action/Comments					
Inspector Comments: FS_ID:23872					
EP_NO: 4114					
Repair Type:					
Crossing Status:					
UCIP Comments: - levee depression on both sides of the levee 2-inch electric conduit on waterside and service pole on landside.					
FIELD_STRUCT_DESC: 18-inch steel pipe through the levee 2 feet below the crown, pump mounted on pile structure pier in the stream. Siphon breaker on the landward slope. Concrete standpipe at the toe of the landward slope. (App. No. 4114-Katie M. Feck) O&M Manual SJR 007, April 1964.					
FS Date: 10/29/2013

WS view: depression on levee shoulder near walkway. Half of the walkway stripped off.

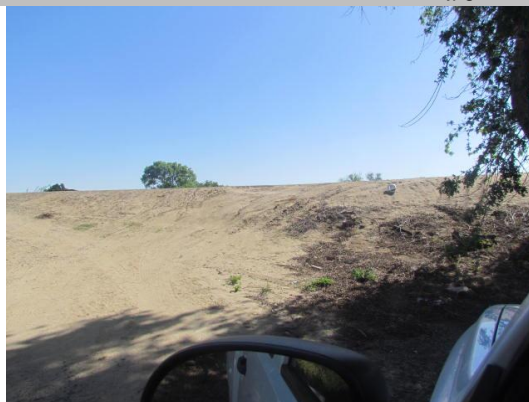
Photo 1 of 1 : richard_s_20140320_287.jpg

LM Start	1.83	Rating **	M	Issue No.	5
LM End	1.83	Issue Type +	Ma	Location *	LS
Category	Earthen Levee			GPS Latitude/Longitude	
				Start	End
Item	Slope Stability			37.853188 °	37.853188 °
				-121.324145 °	-121.324145 °
DWR ID	DWR_RD0544_01_s _ 2013_5				
Action/Comments					
Repair the levee slope damaged by vehicle traffic and prevent access where possible.					
Inspector Comments: Slope damaged by vehicle traffic.

Looking east at landward slope damaged by vehicle traffic.

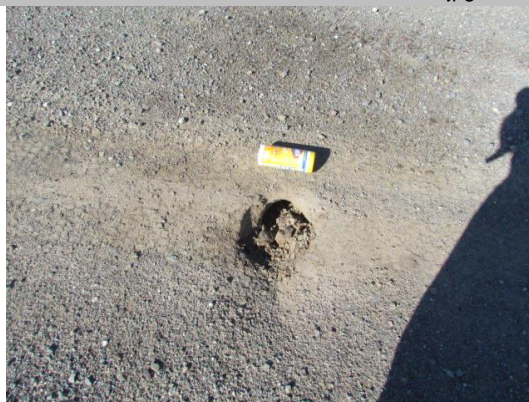
Photo 1 of 1 : richard_s_20140411_531.jpg

Looking at rodent hole on levee crown.

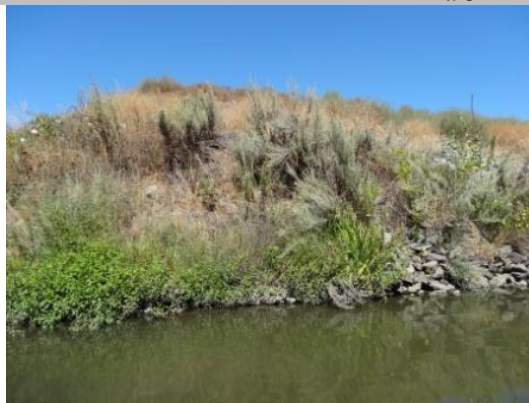
Photo 1 of 1 : richard_s_20140320_306.jpg

LM Start	2.01	Rating **	U	Issue No.	46
LM End	2.01	Issue Type +	Ma	Location *	WS
Category	Supplemental			GPS Latitude/Longitude	
				Start	End
Item	DWR Erosion Survey			37.850534 °	37.850534 °
				-121.322285 °	-121.322285 °
DWR ID	DWR_RD0544_01_s _ 2014_46				
Action/Comments					
Inspector Comments: 08/13/2013: No significant change observed. 08/07/2012: Erosion is right at the inside of a river bend. Dense vegetation is visible at the site. [2013 Site ID:RD0544U01RM48.81]

Front view of erosion.

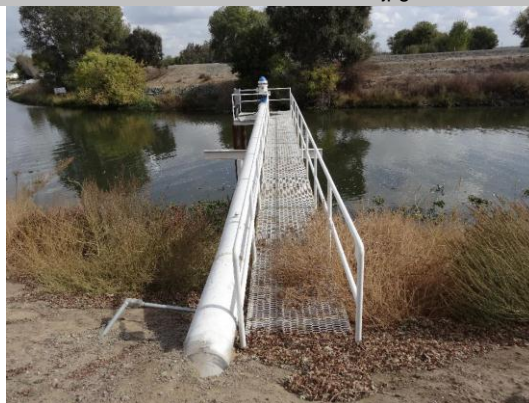
Photo 1 of 1 : UCIP_3835.jpg

LM Start	2.27	Rating **	M	Issue No.	53
LM End	2.27	Issue Type +	En	Location *	WS
Category	Supplemental			GPS Latitude/Longitude	
				Start	End
Item	DWR UCIP Field Study			37.848225 °	37.848225 °
				-121.324868 °	-121.324868 °
DWR ID	DWR_RD0544_01_s _ 2014_53				
Action/Comments					
Inspector Comments: FS_ID:23945					
EP_NO: N/A					
Repair Type:					
Crossing Status:					
UCIP Comments: Siphon breaker on the landward slope not found. It has been removed and pipe plugged. Huge levee slope erosion on landside. 2-inch electric conduit on waterside, service pole on landside.					
FIELD_STRUCT_DESC: 14-inch steel pipe through the levee, 2.0 feet below the crown, pump on pile structure in the stream. Steel walkway to the pump. 2-inch electric conduit on waterside, power pole on landside.					
O&M Manual SJR 007, April 1964.					
FS Date: 10/29/2013

WS view: steel pipe, walkway to the pump, conduit (bottom left) on levee slope.

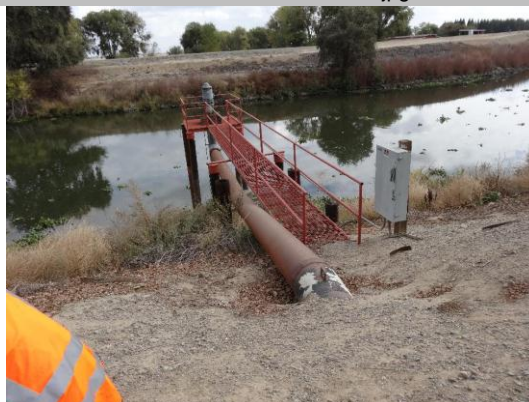
Photo 1 of 1 : UCIP_3840.jpg

LM Start	2.28	Rating **	M	Issue No.	80
LM End	2.28	Issue Type +	En	Location *	WS
Category	Supplemental			GPS Latitude/Longitude	
				Start	End
Item	DWR UCIP Field Study			37.848052 °	37.848052 °
				-121.324846 °	-121.324846 °
DWR ID	DWR_RD0544_01_s _ 2014_80				
Action/Comments					
Inspector Comments: FS_ID:23946					
EP_NO: 3300					
Repair Type:					
Crossing Status:					
UCIP Comments: - erosion on landside and waterside levee slopes due to the pipe leakage.1.5-inch electric conduit					
FIELD_STRUCT_DESC: 18-inch steel pipe through the levee, 3.5 feet below the crown, pump mounted on pile structure in the stream. Siphon breaker on the landward slope. Concrete standpipe and service pole at the toe of the landward slope. (App. No. 3300-Lloyd Phelps) O&M Manual SJR 007, April 1964.					
FS Date: 10/29/2013

WS view: exposed pipe, walkway to pump, pump on pile structure in the stream.

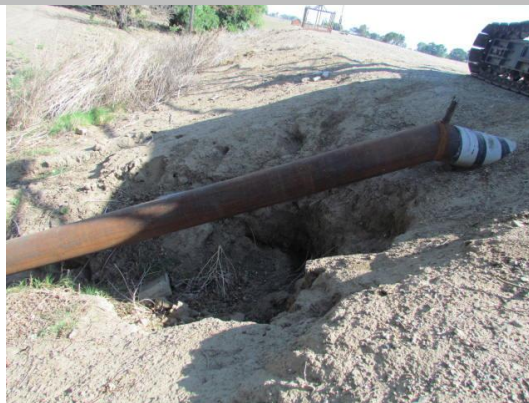
Photo 1 of 2 : richard_s_20140320_299.jpg

LM Start	2.28	Rating **	U	Issue No.	23
LM End	2.28	Issue Type +	Ma	Location *	LS
Category	Earthen Levee			GPS Latitude/Longitude	
				Start	End
Item	Erosion / Bank Caving			37.847985 °	37.847985 °
				-121.324837 °	-121.324837 °
DWR ID	DWR_RD0544_01_s _ 2012_23				
Action/Comments					
Schedule repair of erosion site prior to the next inspection.					
Inspector Comments: Caving/erosion around irrigation pipe on landside slope.

Looking north at erosion under irrigation pipe on landside slope.

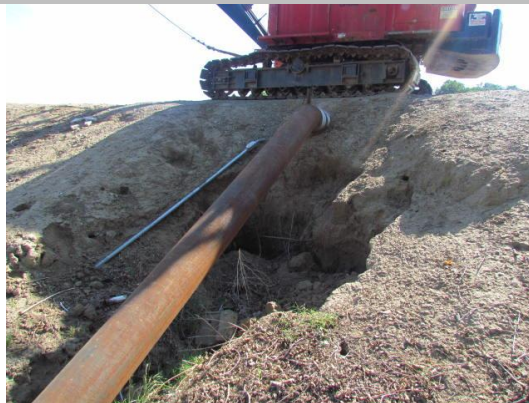
Photo 2 of 2 : richard_s_20140320_300.jpg

LM Start	2.28	Rating **	U	Issue No.	23 (cont)
LM End	2.28	Issue Type +	Ma	Location *	LS
Category	Earthen Levee			GPS Latitude/Longitude	
				Start	End
Item	Erosion / Bank Caving			37.847985 °	37.847985 °
				-121.324837 °	-121.324837 °
DWR ID	DWR_RD0544_01_s _ 2012_23				
Action/Comments					
Schedule repair of erosion site prior to the next inspection. Inspector Comments: Caving/erosion around irrigation pipe on landside slope.

Looking east at erosion under irrigation pipe on landside slope.

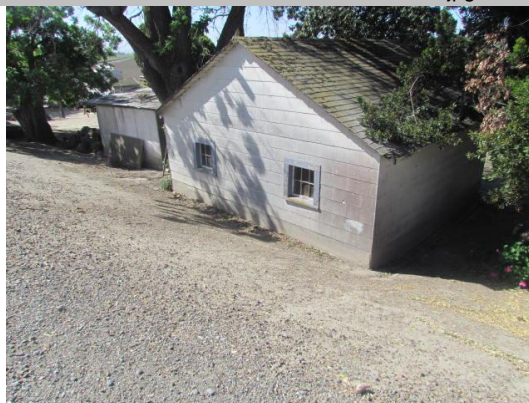
Photo 1 of 1 : richard_s_20140320_315.jpg

Looking southeast at building at landward toe.

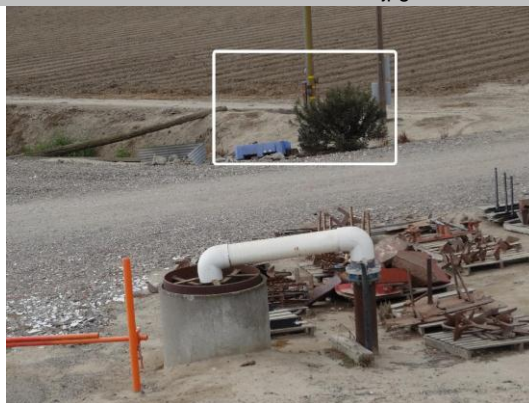
Photo 1 of 1 : UCIP_4331.jpg

LM Start	2.45	Rating **	M	Issue No.	82
LM End	2.45	Issue Type +	En	Location *	LS
Category	Supplemental			GPS Latitude/Longitude	
				Start	End
Item	DWR UCIP Field Study			37.845968 °	37.845968 °
				-121.323357 °	-121.323357 °
DWR ID	DWR_RD0544_01_s_2014_82				
Action/Comments					
Inspector Comments: FS_ID:24888					
EP_NO: N/A					
Repair Type:					
Crossing Status:					
UCIP Comments: - pipe 2 ft. below the crown, soil around the siphon breaker eroded.					
FIELD_STRUCT_DESC: 8-inch pipe through the levee, 2 feet below the crown. Siphon breaker waterside slope. Pump on drainage channel bank.					
FS Date: 10/29/2013

LS view: pump on drainage ditch bank about 140 ft from the levee.

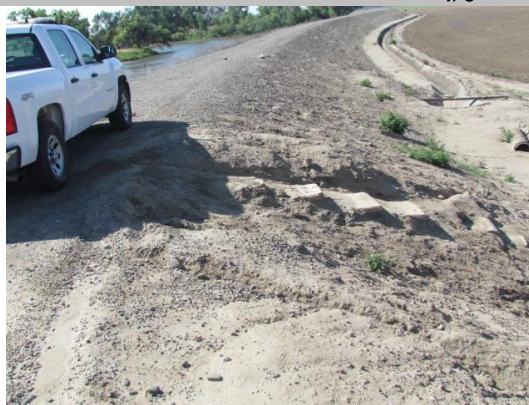
Photo 1 of 2 : richard_s_20140320_309.jpg

LM Start	2.58	Rating **	M	Issue No.	60
LM End	2.58	Issue Type +	Ma	Location *	LS
Category	Earthen Levee			GPS Latitude/Longitude	
				Start	End
Item	Slope Stability			37.844337 °	37.844337 °
				-121.321853 °	-121.321853 °
DWR ID	DWR_RD0544_01_s_2012_60				
Action/Comments					
Repair the levee slope damaged by foot traffic and prevent access where possible.

Looking south at slope damage on landside slope.

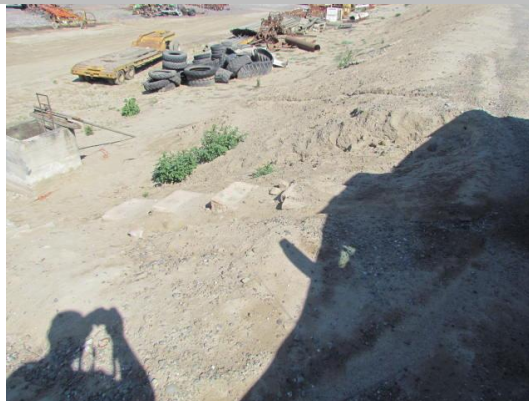
Photo 2 of 2 : richard_s_20140320_310.jpg

LM Start	2.58	Rating **	M	Issue No.	60 (cont)
LM End	2.58	Issue Type +	Ma	Location *	LS
Category	Earthen Levee			GPS Latitude/Longitude	
				Start	End
Item	Slope Stability			37.844337 °	37.844337 °
				-121.321853 °	-121.321853 °
DWR ID	DWR_RD0544_01_s _ 2012_60				
Action/Comments					
Repair the levee slope damaged by foot traffic and prevent access where possible.

Looking north at slope damage on landside slope.

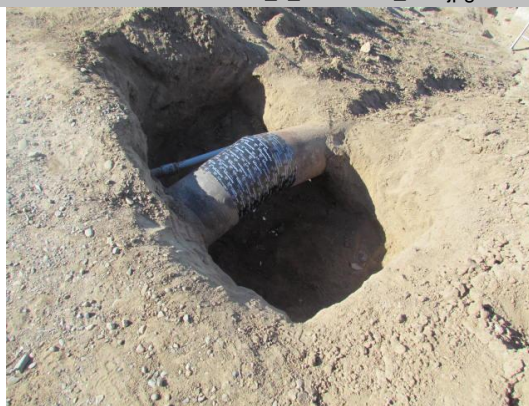
Photo 1 of 1 : richard_s_20140411_532.jpg

LM Start	2.59	Rating **	M	Issue No.	91
LM End	2.59	Issue Type +	En	Location *	LS
Category	Earthen Levee			GPS Latitude/Longitude	
				Start	End
Item	Encroachments			37.844423 °	37.844423 °
				-121.321896 °	-121.321896 °
DWR ID	DWR_RD0544_01_s _ 2014_91				
Action/Comments					
Pipe Inspector Comments: Landowner repaired pipe without maintanance letter.

Looking at open trench with irrigation pipe on landward shoulder and slope.

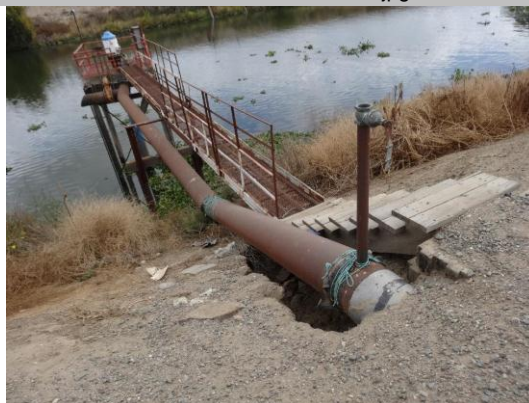
Photo 1 of 1 : UCIP_4336.jpg

UCIP Comments: Siphon breaker on the landward shoulder not found. Service pole on landside. Huge erosion on landside and waterside of the levee due to the pipe leakage.

WS view: exposed pipe, walkway to pump, and pump on pile structure in the stream.

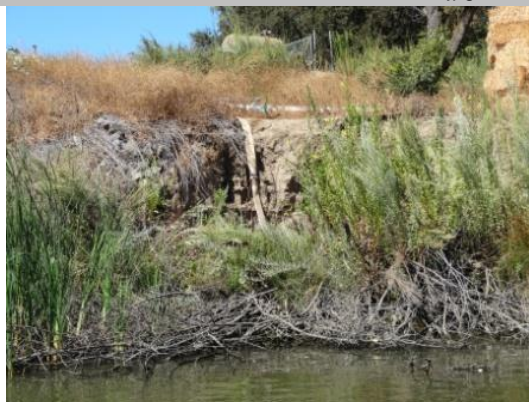
Photo 1 of 1 : richard_s_20140320_320.jpg

LM Start	2.94	Rating **	U	Issue No.	77
LM End	2.94	Issue Type +	Ma	Location *	WS
Category	Supplemental			GPS Latitude/Longitude	
				Start	End
Item	DWR Erosion Survey			37.840697 °	37.840697 °
				-121.318252 °	-121.318252 °
DWR ID	DWR_RD0544_01_s _ 2014_77				
Action/Comments					
Inspector Comments: 08/13/2013: Pump has been removed. A larger pocket erosion has been found at the erosion site. 08/07/2012: Erosion is immediately upstream of a river bend. Dense vegetation is visible at the erosion site. [2013 Site ID:RD0544U01RM49.67]

Close view of the site. Erosion has worsened and more vegetation is visible.

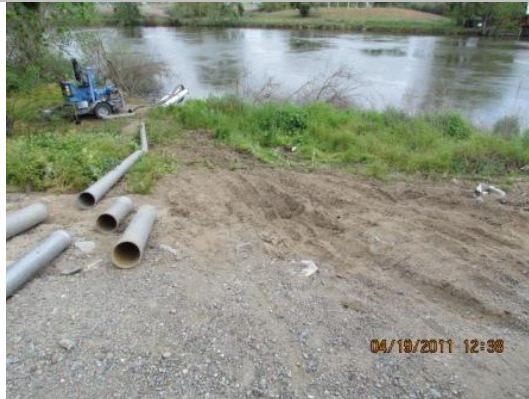
Photo 1 of 8 : richard_s_20140320_290.jpg

LM Start	2.98	Rating **	U	Issue No.	16
LM End	2.98	Issue Type +	En	Location *	LS
Category	Earthen Levee			GPS Latitude/Longitude	
				Start	End
Item	Encroachments			37.840483 °	37.840483 °
				-121.318370 °	-121.318370 °
DWR ID	DWR_RD0544_01_s _ 2012_16				
Action/Comments					
Pipe					
Inspector Comments: Landowner installing temporary irrigation system across levee crown without permit. Pipe is leaking and causing erosion on waterside slope and berm. Landowner also installed a concrete wall around pump.

Looking east at landowner installing temporary pump system without permit and damage to waterside slope.

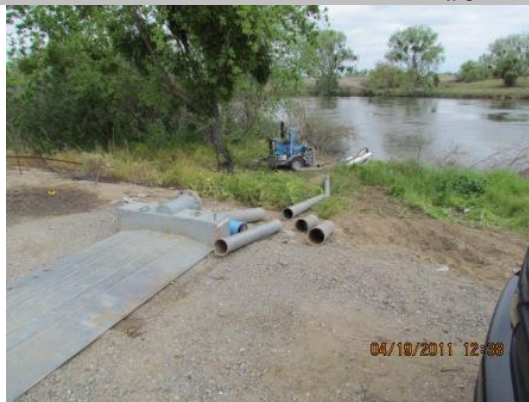
Photo 2 of 8 : richard_s_20140320_291.jpg

Looking east at pump and irrigation ramp on levee waterside and crown.

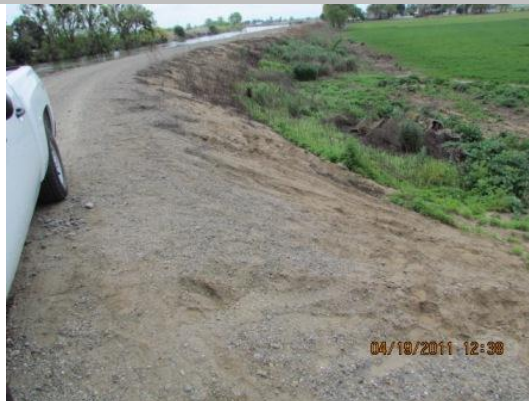
Photo 3 of 8 : richard_s_20140320_292.jpg

Looking south at damage landside slope caused by vehicle traffic.

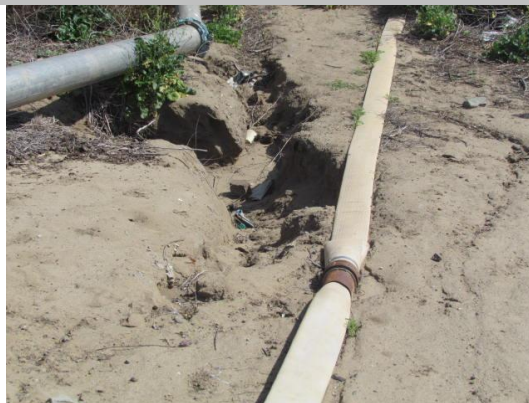
Photo 5 of 8 : richard_s_20140320_294.jpg

Looking east at erosion caused by leaking pipe on waterside slope.

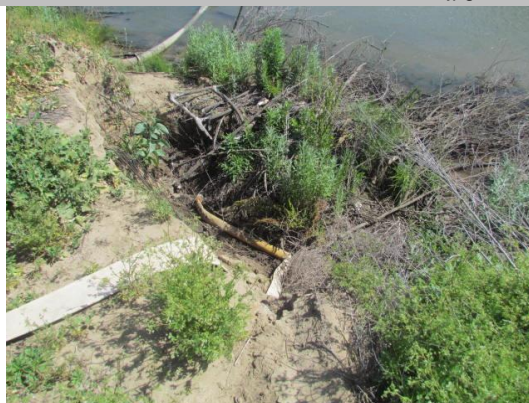
Photo 7 of 8 : richard_s_20140320_296.jpg

Looking east at erosion caused by leaking hose on waterward berm.
(Spring 2013)

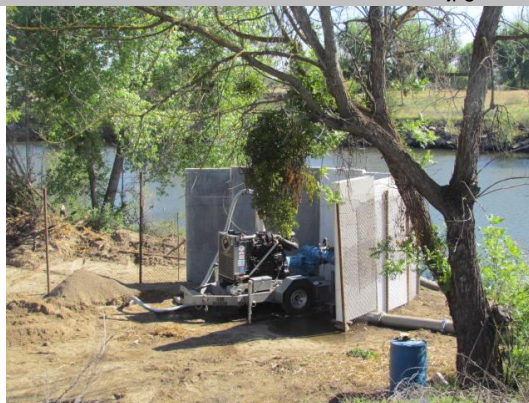
Photo 8 of 8 : richard_s_20140411_533.jpg

Looking east at concrete wall around temporary pump on waterward berm. (Spring 2014)

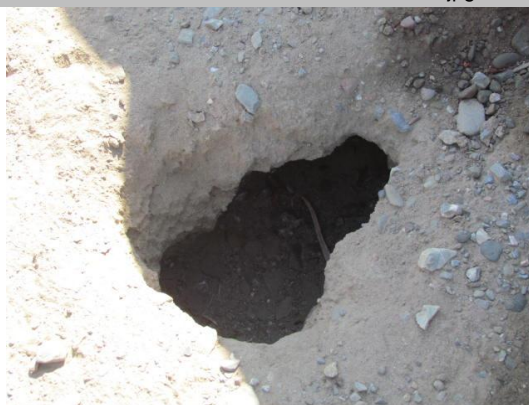
Photo 1 of 3 : richard_s_20140320_316.jpg

LM Start	2.98	Rating **	M	Issue No.	75
LM End	2.98	Issue Type +	Ma	Location *	WS
Category	Earthen Levee			GPS Latitude/Longitude	
				Start	End
Item	Erosion / Bank Caving				o
					o
DWR ID	DWR_RD0544_01_f_2013_75				
Action/Comments					
Schedule repair of erosion site prior to the next inspection. Inspector Comments: Hole on levee crown shoulder. Hole is 16"x18"x24.Hole is undermining back toward landward slope.

Looking at large hole on waterward shoulder.

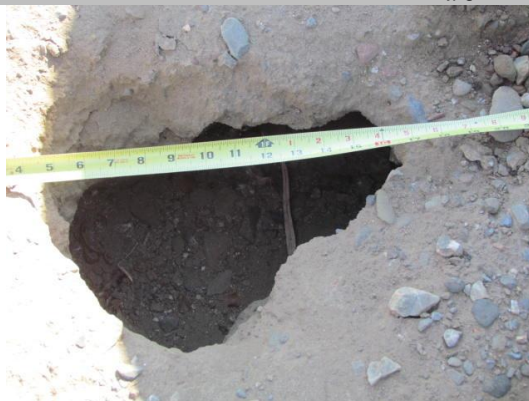
Photo 2 of 3 : richard_s_20140320_317.jpg

Looking at hole on waterward shoulder.

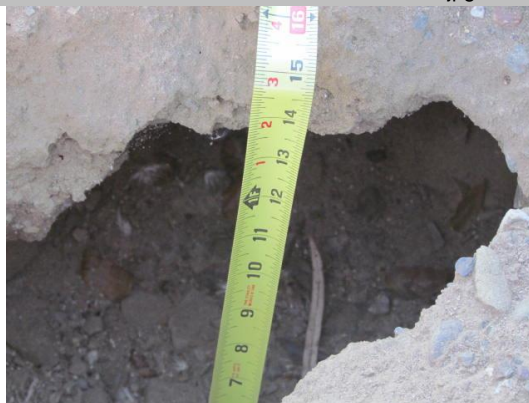
Photo 3 of 3 : richard_s_20140320_318.jpg

LM Start	2.98	Rating **	M	Issue No.	75 (cont)	
LM End	2.98	Issue Type +	Ma	Location *	WS	
Category	Earthen Levee			GPS Latitude/Longitude		
				Start		End
Item	Erosion / Bank Caving				°	°
					°	°
DWR ID	DWR_RD0544_01_f_2013_75					
Action/Comments						
Schedule repair of erosion site prior to the next inspection.

Looking at hole approx. 16" deep on waterward shoulder.

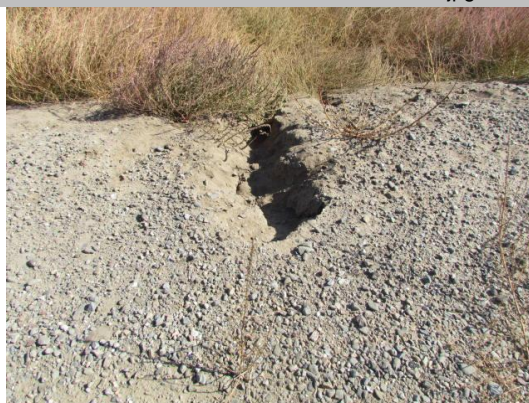
Photo 1 of 1 : richard_s_20140320_319.jpg

LM Start	3.15	Rating **	M	Issue No.	76
LM End	3.15	Issue Type +	Ma	Location *	WS
Category	Earthen Levee			GPS Latitude/Longitude	
				Start	End
Item	Slope Stability			37.837929 °	37.837929 °
				-121.317663 °	-121.317663 °
DWR ID	DWR_RD0544_01_f_2013_76				
Action/Comments					
Repair slope instability. Inspector Comments: Slope damaged extends from levee slope to shoulder.

Looking east at slope damage on waterward slope.

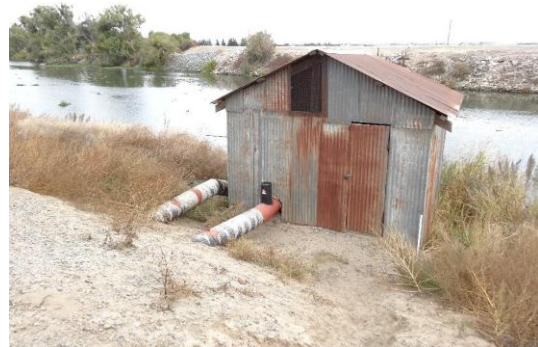
Photo 1 of 1 : UCIP_3922.jpg

LM Start	3.19	Rating **	M	Issue No.	84
LM End	3.19	Issue Type +	En	Location *	WS
Category	Supplemental			GPS Latitude/Longitude	
				Start	End
Item	DWR UCIP Field Study			37.837556 °	37.837556 °
				-121.317523 °	-121.317523 °
DWR ID	DWR_RD0544_01_s_2014_84				
Action/Comments					
Inspector Comments: FS_ID:23990					
EP_NO: N/A					
Repair Type:					
Crossing Status:					
UCIP Comments: - huge levee slope erosion on landside.1-inch electric conduit, power pole on landside.not clear whether this is a irrigation or drainage pipe.					
FIELD_STRUCT_DESC: 1 of 2: Two 14-inch steel pipes through the levee, 8.0 feet below the crown. Slide gates in 6-foot by 6-foot concrete distribution box at the toe of the landward slope. O&M Manual SJR 007, April 1964.					
FS Date: 10/29/2013

WS view: exposed steel pipes, levee slope, and pumphouse for 2nd

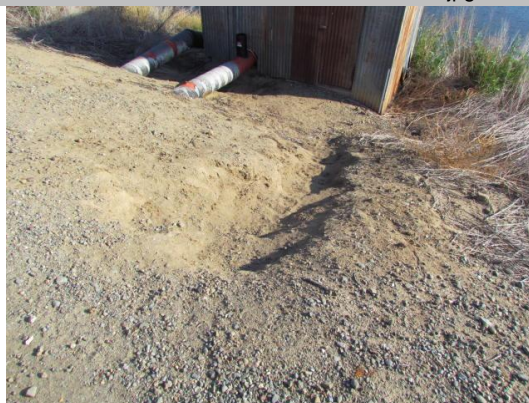
Photo 1 of 1 : richard_s_20140320_311.jpg

Looking east at slope damaged by foot traffic near pump house on waterside of levee.

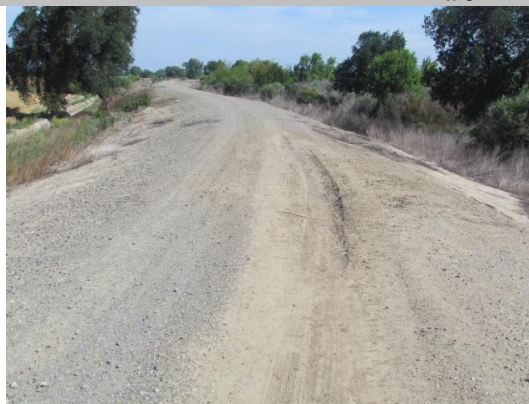
Photo 1 of 1 : richard_s_20140320_312.jpg

Looking south at one of several sites needing gravel or road base on levee crown.

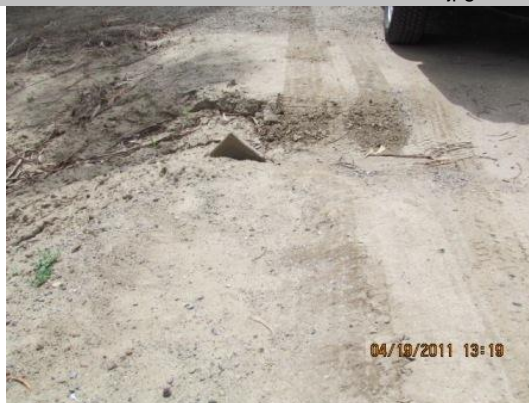
Photo 1 of 2 : richard_s_20140320_307.jpg

Looking south at depression greater than 6" on waterside shoulder.

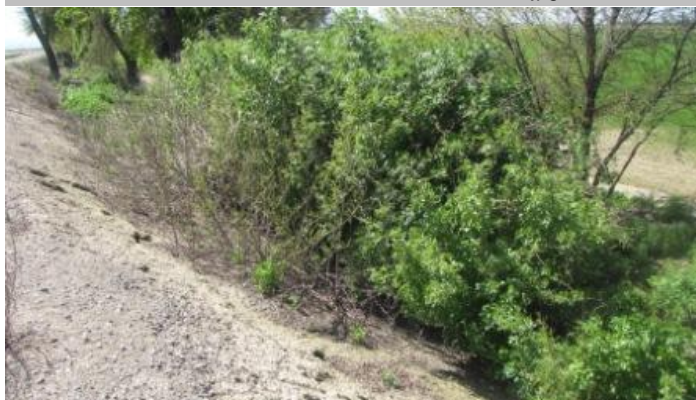
Photo 1 of 1 : richard_s_20140320_304.jpg

Looking south at elderberries on landside slope and toe.

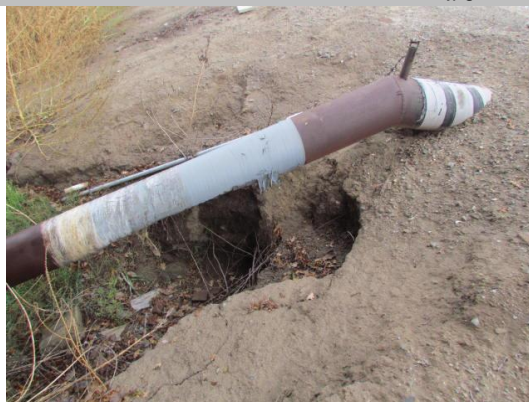
Photo 1 of 2 : richard_s_20140320_301.jpg

Looking north at erosion around irrigation pipe on landside

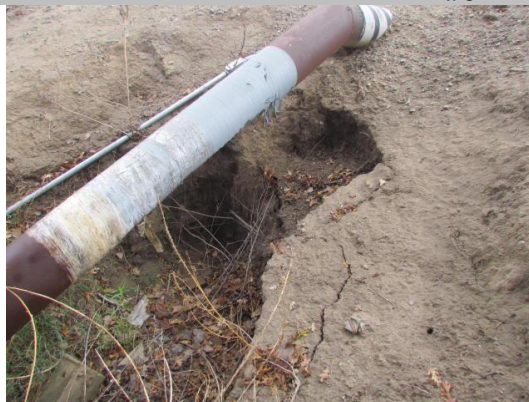
Photo 2 of 2 : richard_s_20140320_302.jpg

Looking northeast at erosion around irrigation pipe on landside slope.

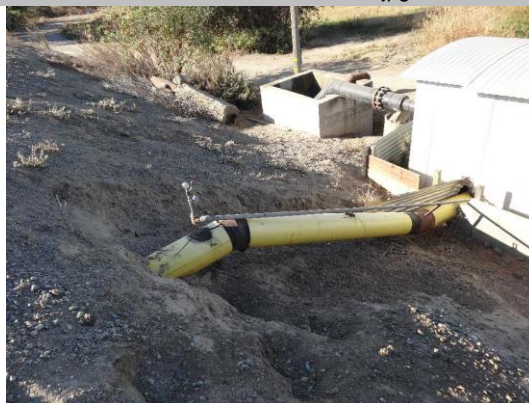
Photo 1 of 1 : UCIP_4351.jpg

LS view: distribution box (top-left), pumphouse (right) and exposed leaky pipe on eroded levee slope.

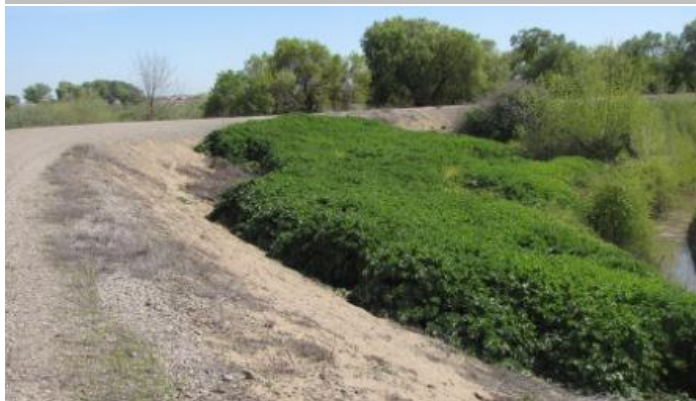
Photo 1 of 1 : richard_s_20140320_303.jpg

Looking southeast at dense veg. on landside slope and toe.

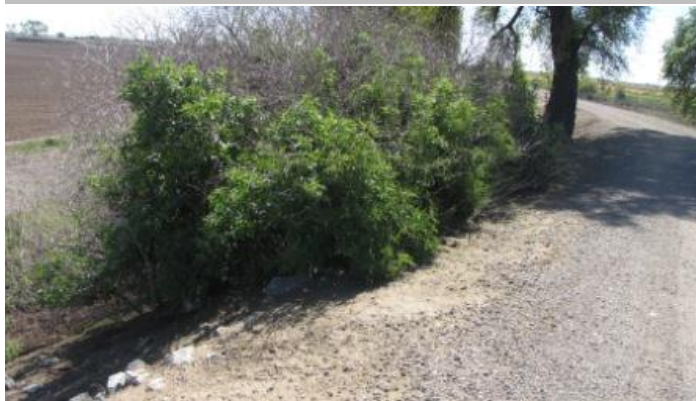
Photo 1 of 3 : richard_s_20140320_334.jpg

Looking northwest at elderberries on landside slope and toe.

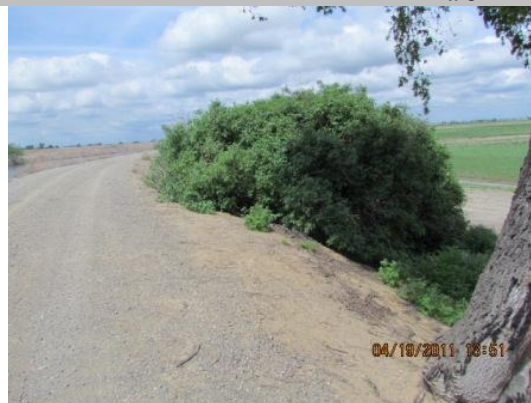
Photo 2 of 3 : richard_s_20140320_335.jpg

Looking south at elderberries on landside slope.

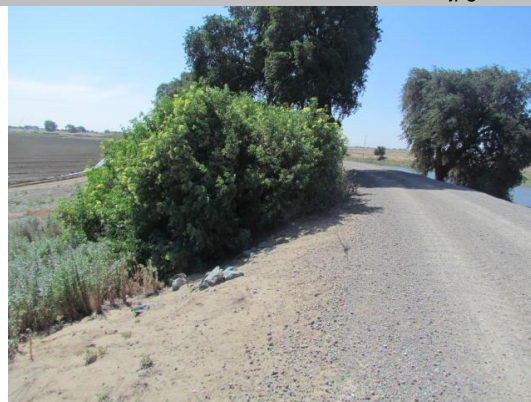
Photo 3 of 3 : richard_s_20140320_336.jpg

Looking northwest at elderberry on landside slope. (Spring 2012)

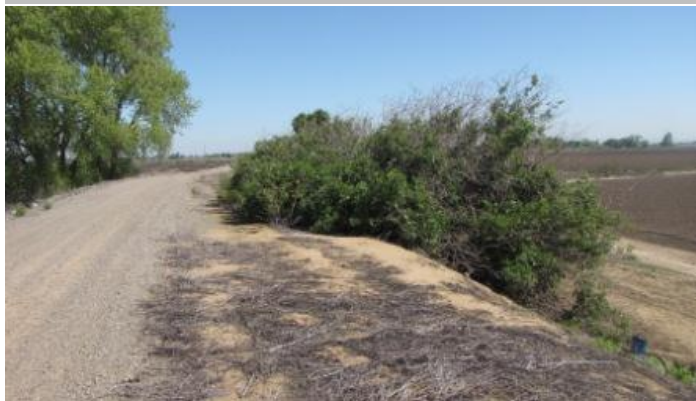
Photo 1 of 1 : richard_s_20140320_337.jpg

Looking south at elderberries on landside slope and toe.

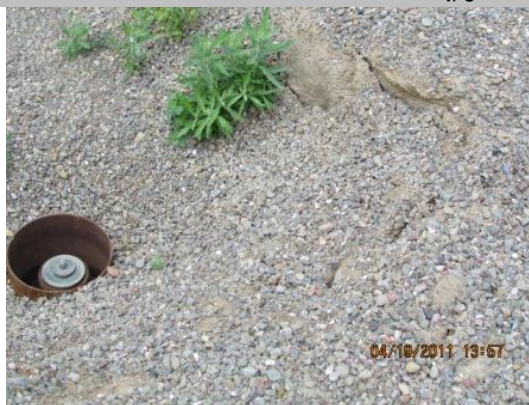
Photo 5 of 8 : richard_s_20140320_343.jpg

Looking at top of siphon with a depression greater than 6" on waterside shoulder.

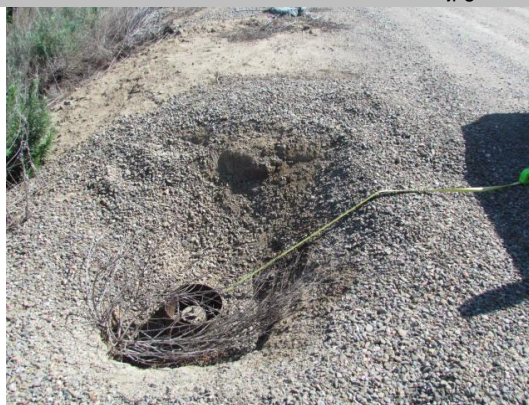
Photo 7 of 8 : richard_s_20140320_345.jpg

Looking south at caving around siphon on waterside shoulder. (Spring 2012)

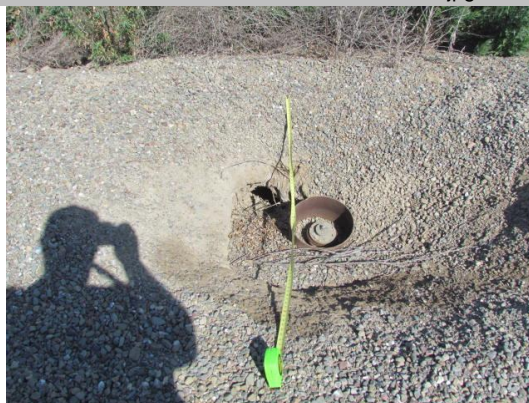
Photo 8 of 8 : richard_s_20140320_346.jpg

Looking east at caving around siphon on waterside shoulder. (Spring 2012)

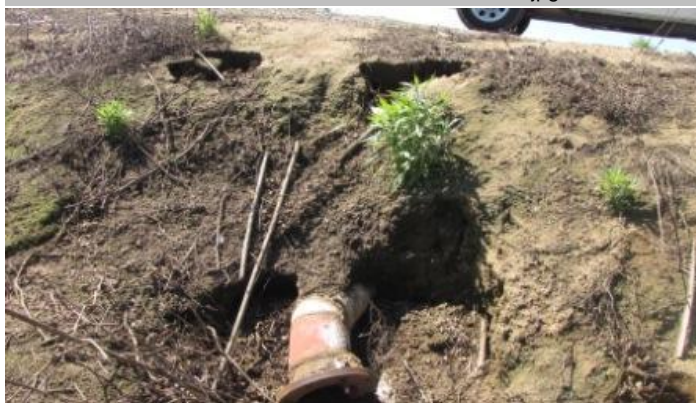
Photo 2 of 3 : richard_s_20140320_361.jpg

Looking east at pipe and erosion just above pipe on landside slope and shoulder.

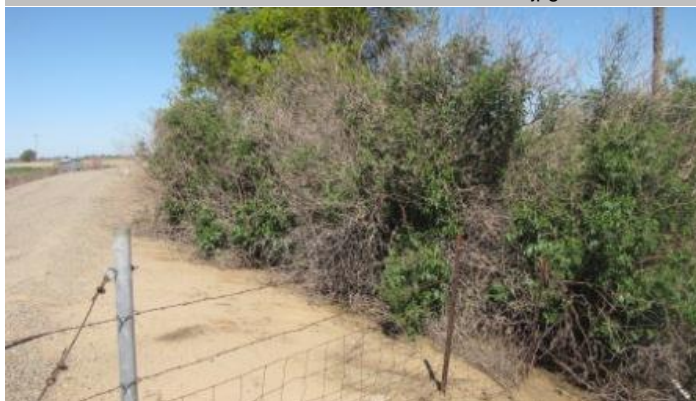
Photo 1 of 2 : richard_s_20140320_348.jpg

Looking south at elderberries on landside slope and toe.

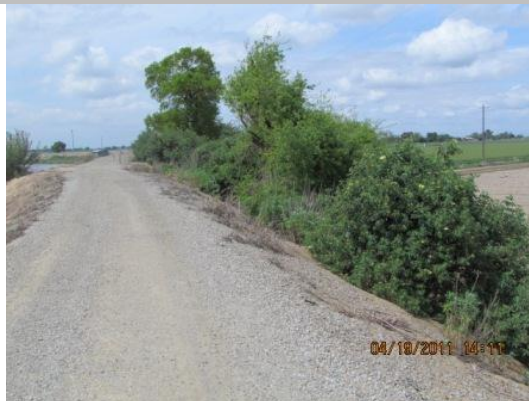
Photo 2 of 2 : richard_s_20140320_349.jpg

Looking southwest at elderberries on landside slope.

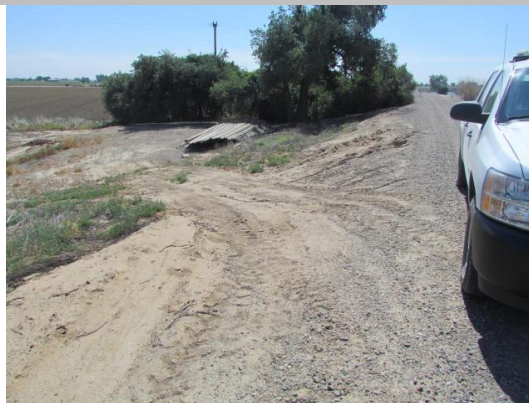
Photo 1 of 1 : richard_s_20140320_363.jpg

Looking northwest at slope damage caused by vehicle traffic.

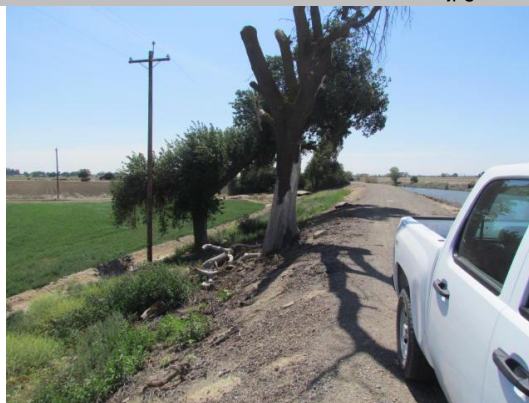
Photo 1 of 1 : richard_s_20140320_364.jpg

Looking north at dead tree and tree limbs on landside shoulder and slope.

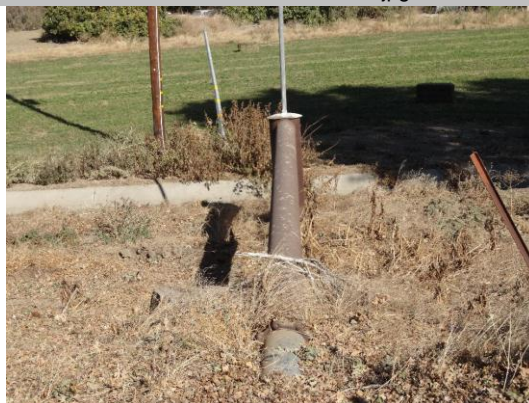
Photo 1 of 1 : UCIP_4087.jpg

LS view: exposed steel pipe and air vent on levee berm. No pump found.

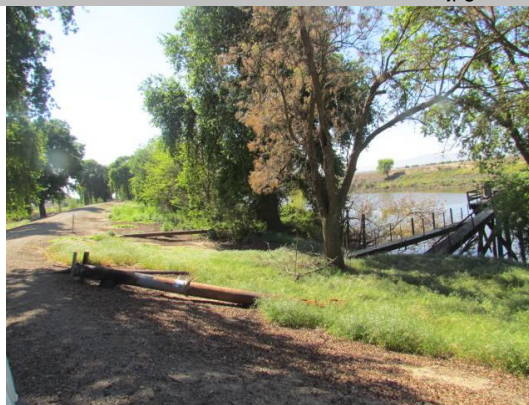
Photo 1 of 1 : richard_s_20140411_535.jpg

Looking north at old pump shaft and pipe on waterward slope.

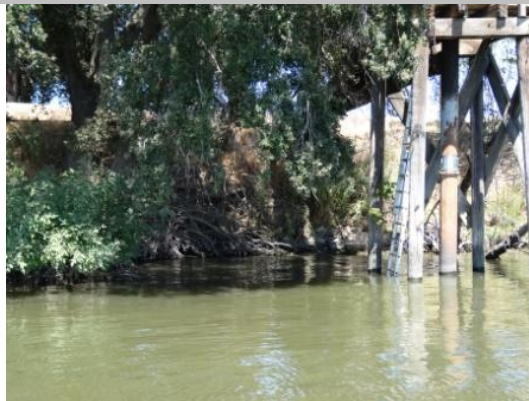
Photo 1 of 1 : richard_s_20140320_347.jpg

Front view of the erosion site. View is partially blocked by the pump structure and vegetation.

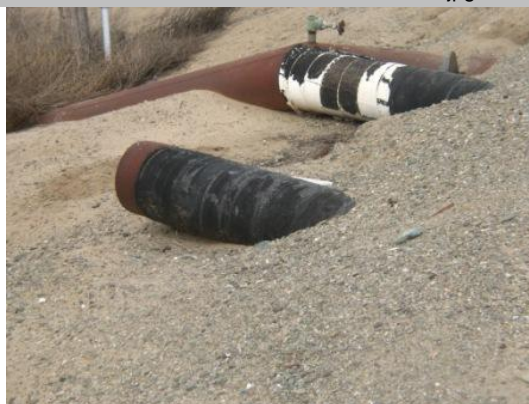
Photo 1 of 1 : richard_s_20140320_352.jpg

Abandoned pipe at LM 2.65, landside view.

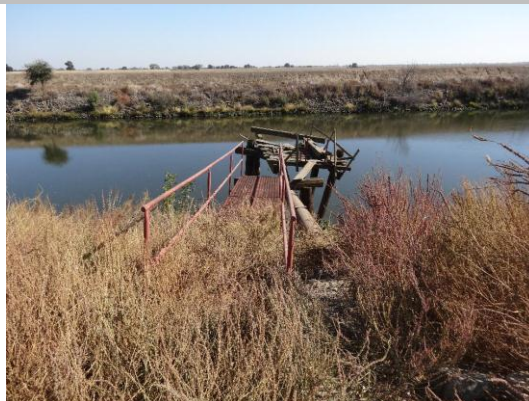
Photo 1 of 1 : UCIP_4090.jpg

WS view: dilapalated walkway and pile structure. Pump removed.

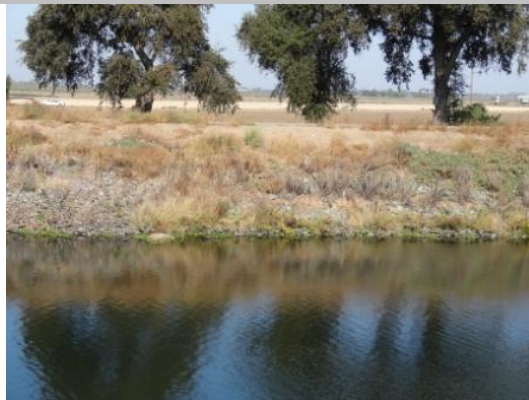
Photo 1 of 1 : richard_s_20140320_350.jpg

Front view of pocket erosion. Note the vegetation and riprap at the site.

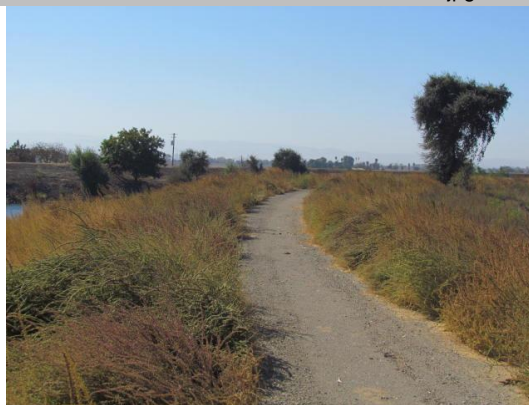
Photo 1 of 1 : richard_s_20140320_370.jpg

Looking south a dense vegetation on landward and waterward slope.

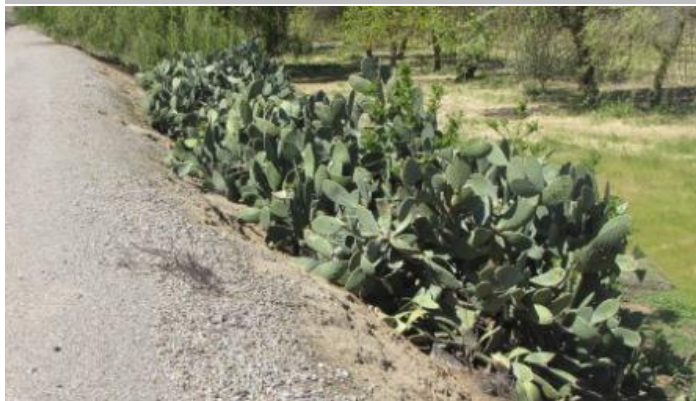
Photo 1 of 2 : richard_s_20140320_368.jpg

Looking southwest at overgrown cactus on landside slope.
